National Highway Traffic Safety Administration

Case Vehicle (A): 1998 Pontiac Type: Sunfire, 2-door coupe

Vehicle (B): 1995 Chevrolet Type: Corvette, 2-door coupe

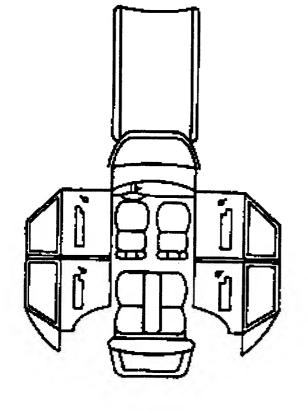
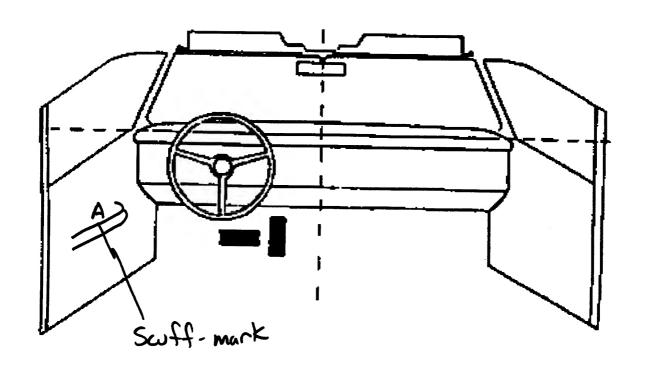
VEHICLE OCCUPANT CONTACT DIAGRAM

Intrusion IT-1
					(All Measurements Are in Centimeters)
Location Intrusion	of 1	Intruded	Component	Compari Value	son Intruded Crush Value = Intrusion Dominant Crush Direction
		armr	est	62	-60 = 2 to ruht
			•		_ =
					_ =
					_ =
					- =
					- =
					- =
					_ =
					_ =
					_ =
					- =
					= =
					- =
					- =
					- =
			C	CCUPANT C	ONTACT WORKSHEET
Contact	Co	Interior omponent ontacted	Occupant No. if Known	Body Region if Known	Confidence Level of Contact Supporting Physical Evidence Point
Α	Ar	n rest	1	Hip	Scuffmark 2
В					
С					
D					
E					
F		<u> </u>			
G					
Н					
ı					
	+

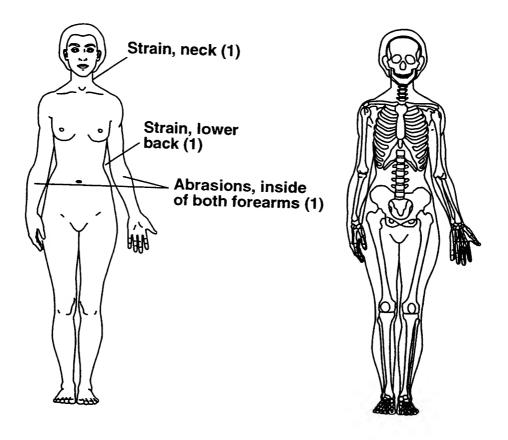
INDICATE LOCATION OF INJURIES.
